Arboricultural Implications Assessment and Arboricultural Method Statement

Bonnyknox, Arbroath, Angus, DD11 2PR

Arthian

21 May 2025

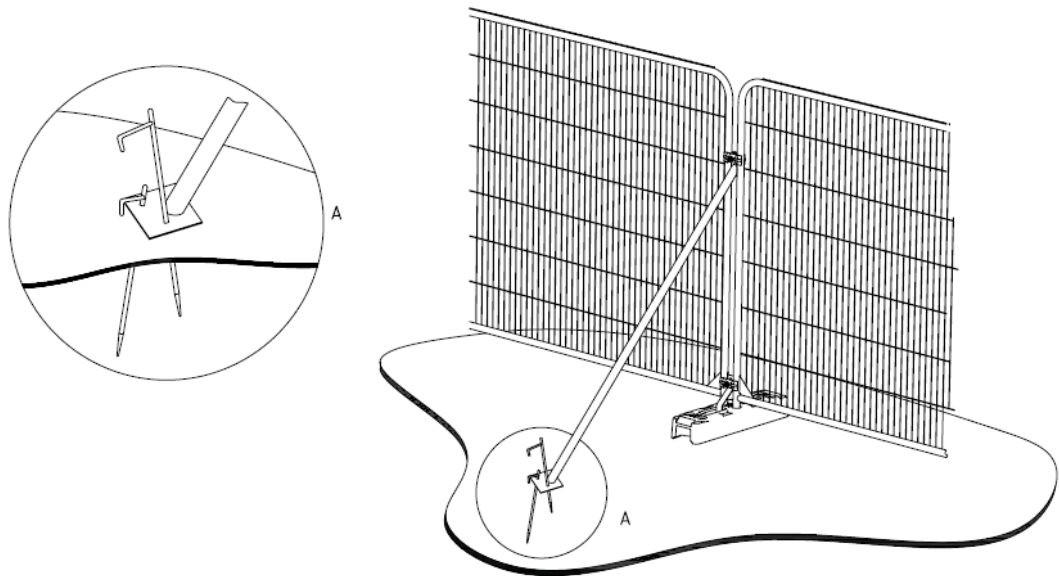
- 3.4.3. The protective fencing shall be at least 2.1m in height and comprise standard 'Heras' welded mesh fence panels mounted on rubber or concrete feet (see image below). The panels shall be fixed to each other with at least two anti-tamper clamps, installed so that they can only be removed from inside the fence.

- 3.4.4. The fencing shall be supported on the side closest to the retained trees by stabiliser struts braced to the ground at an angle of 45 degrees, and attached to a base plate secured to the ground with ground pins. Where the fencing is to be erected on retained hard surfacing or it is otherwise unfeasible to use ground pins, e.g. due to the presence of underground services, the stabiliser struts should be mounted on a block tray. Notices stating "Tree Protection Zone – Keep Out" will be attached with cable ties to every other panel.

a) Stabilizer strut with base plate secured with ground pins
